**ASSESSMENT OF DAMAGED WATER SUPPLY NETWORKS**  
**DURING FEBRUARY 6<sup>TH</sup> KAHRAMANMARAŞ EARTHQUAKES:**  
**THE CASE OF ADIYAMAN**

**ADEM EREN ŞENTÜRK**

**A THESIS OF MASTER OF SCIENCE**  
**DEPARTMENT OF CIVIL ENGINEERING**

**JANUARY 2025**

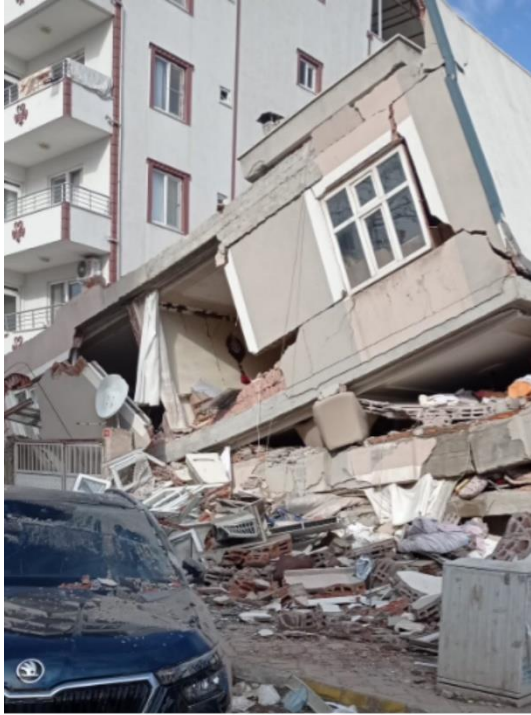
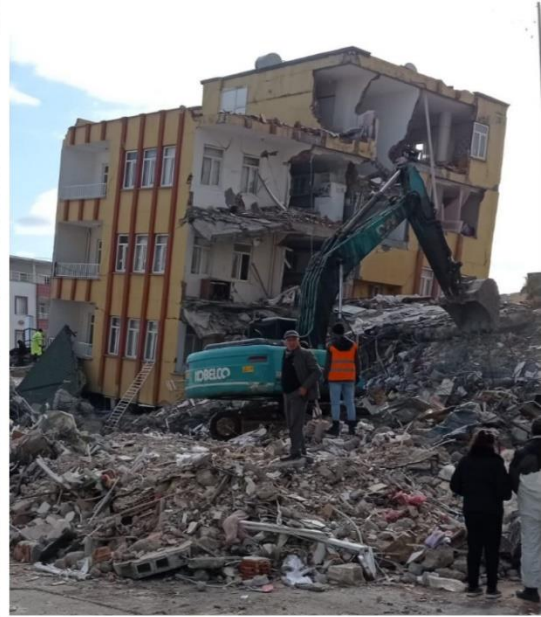
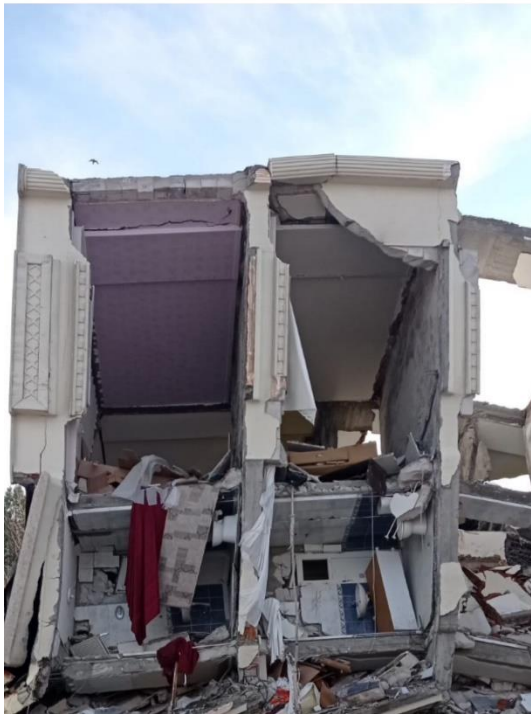
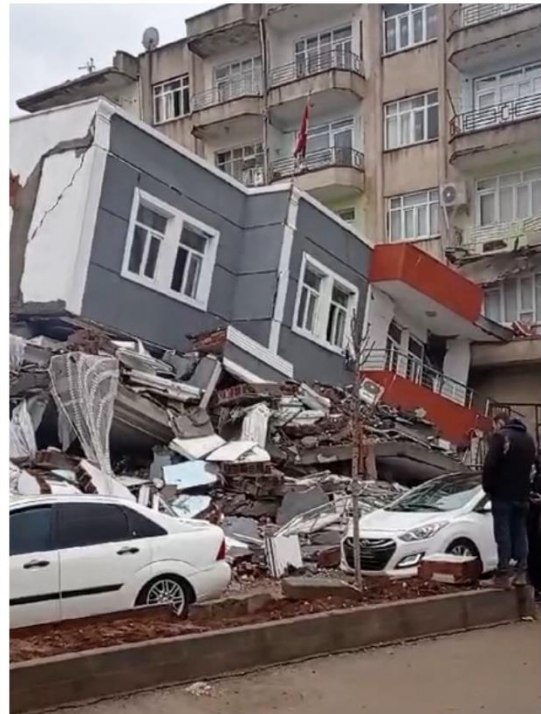
**Figure 3.9:** Damaged buildings in Adıyaman city center.

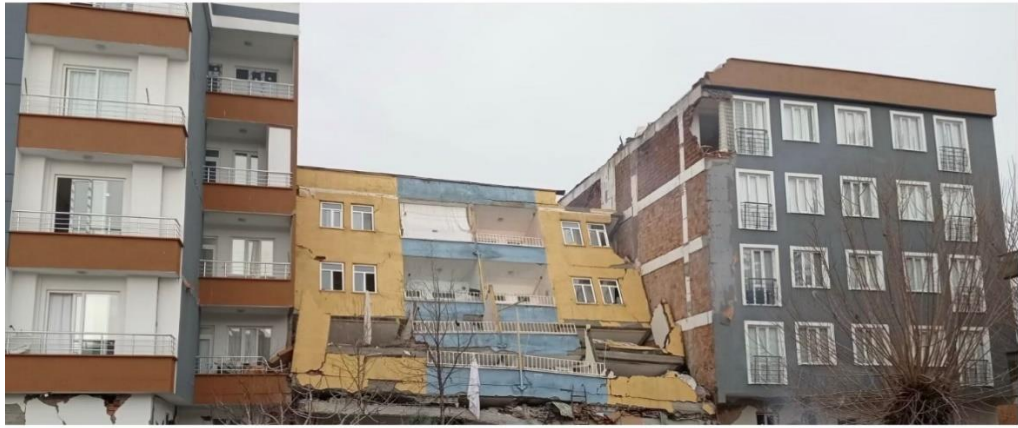
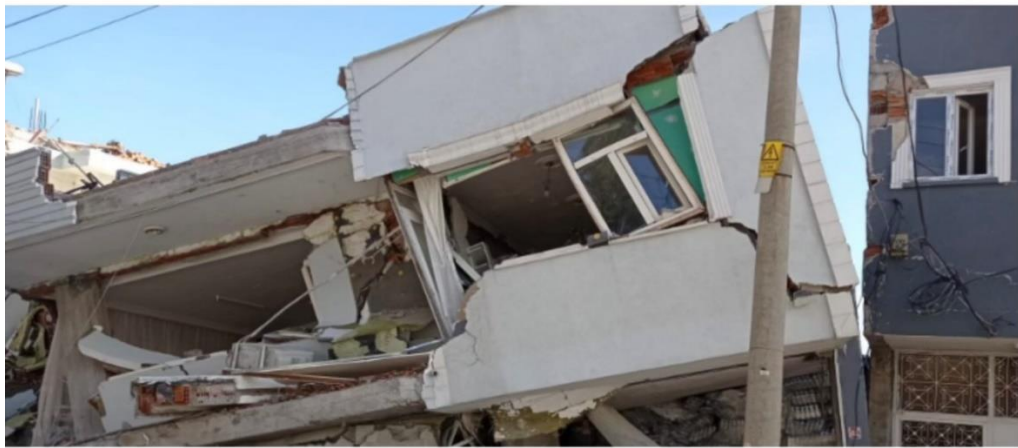
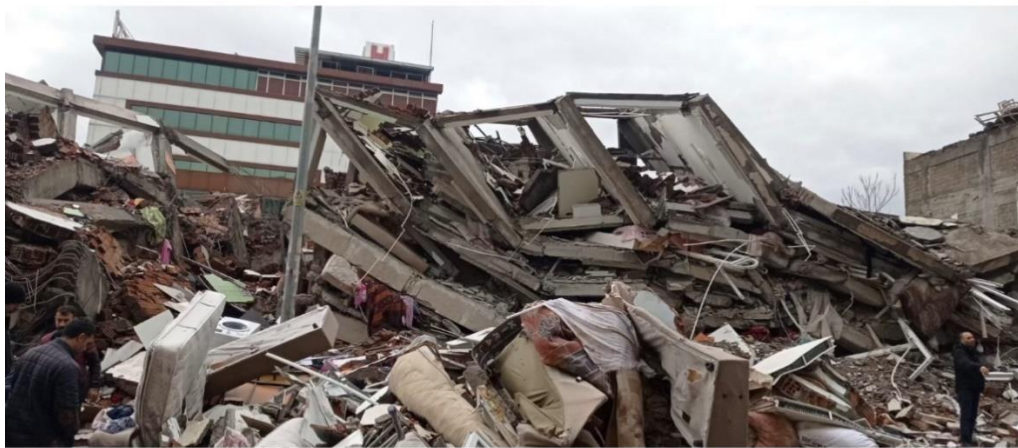
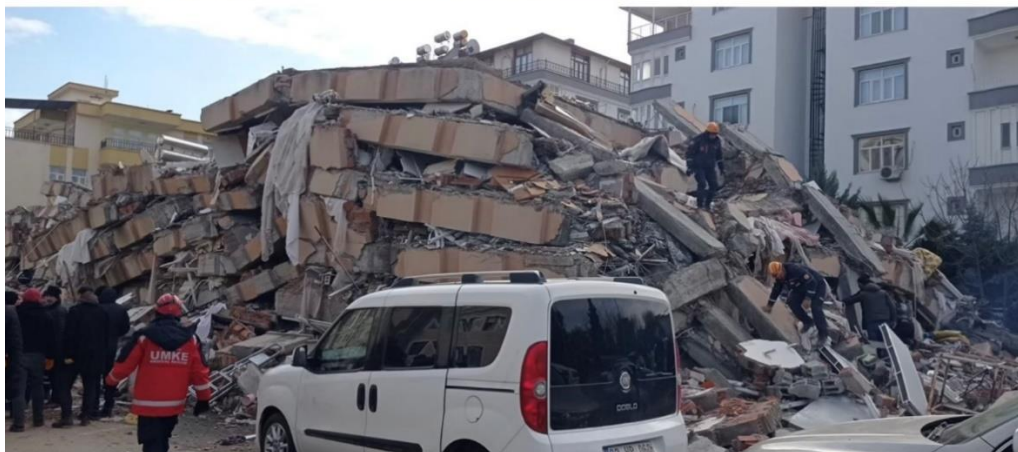
**Figure 3.10:** Collapsed buildings in Adiyaman city center.

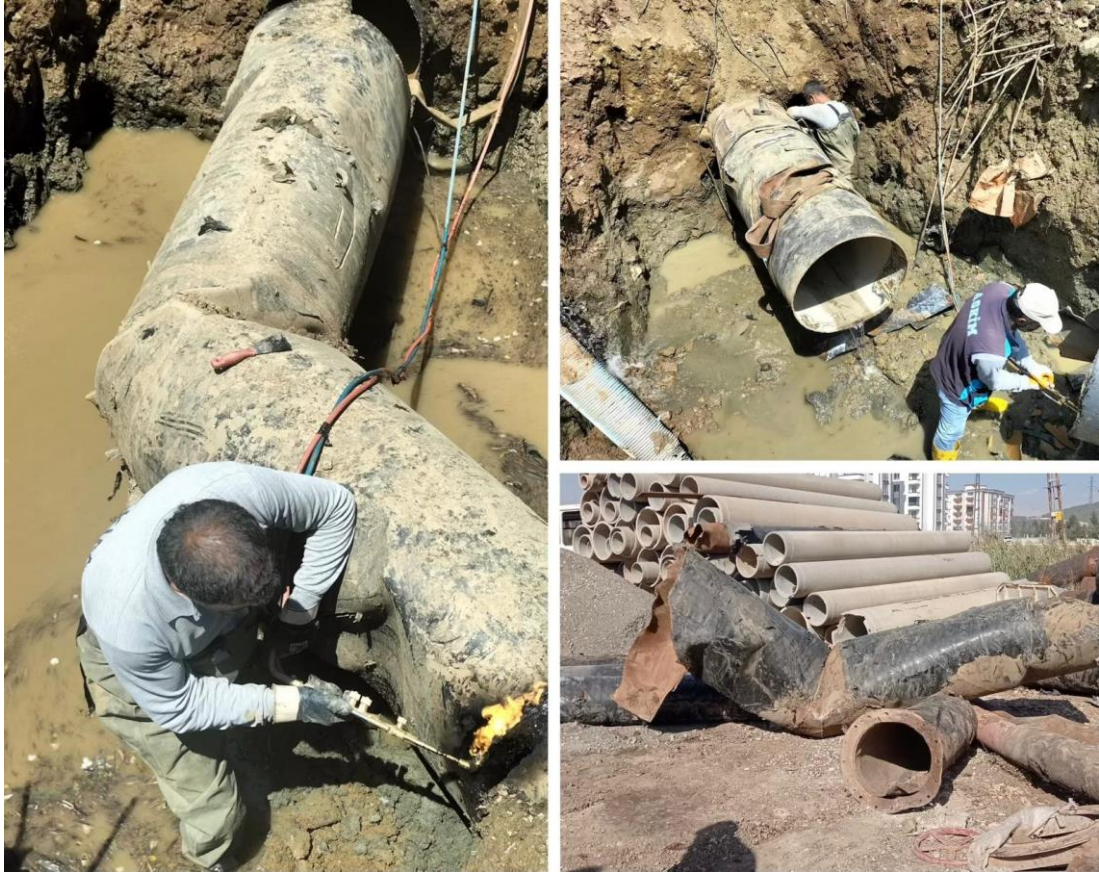
**Figure 6.2:** Repair process of the damaged  $\Phi$  700 mm steel pipe.

**Figure 6.2** includes photographs of a damage point along this pipeline. At this location, a  $\Phi$  700 mm diameter steel pipe was severely bent at its elbow joint due to the impact of the earthquake. The damage point is approximately 400 meters from the source and directly intersects with the mentioned fault line. It is evident that fault movement caused the damage at this location. Furthermore, for approximately 800 meters following the damage point, the pipeline runs in close proximity and parallel to the fault line.

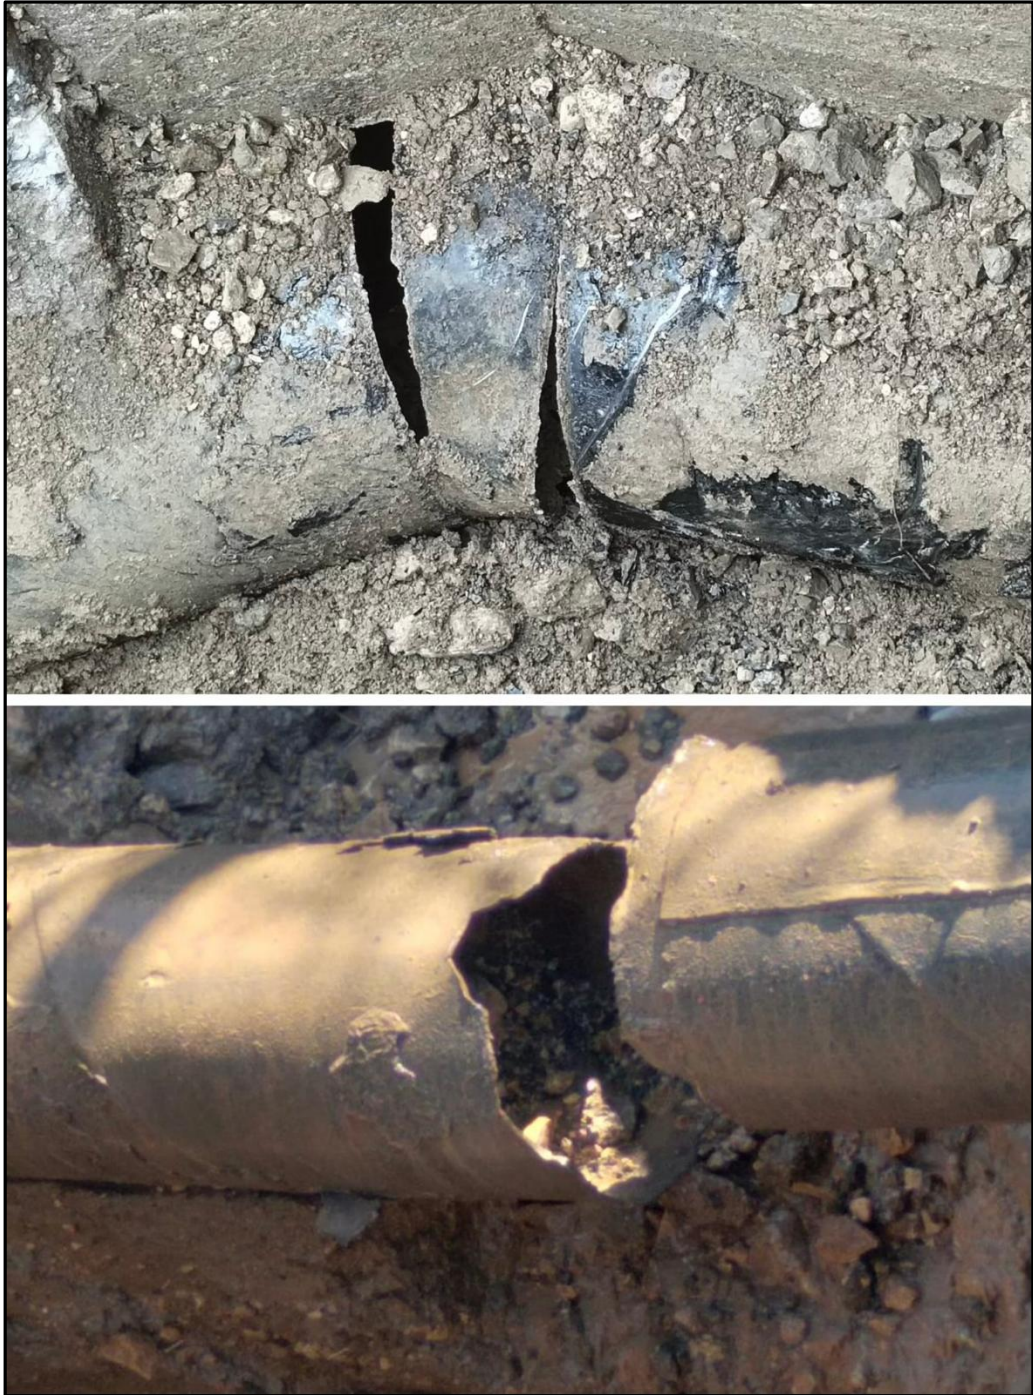
**Figure 6.6:** Damages in Gürlevik 2 transmission line.

The distance between the damaged sections and the nearest surface fault rupture varies between approximately 8 and 16 km. The Gürlevik 2 transmission line transports water from the source, located at an elevation of approximately 1300 meters, to the Adıyaman city center at an elevation of approximately 700 meters. This is achieved through gravity-driven flow across regions with varying slopes and through terrains with differing geological structures. **Table 6.2** provides information regarding the damages on the specified line, including their locations, distances to the nearest surface rupture and distance from water source.

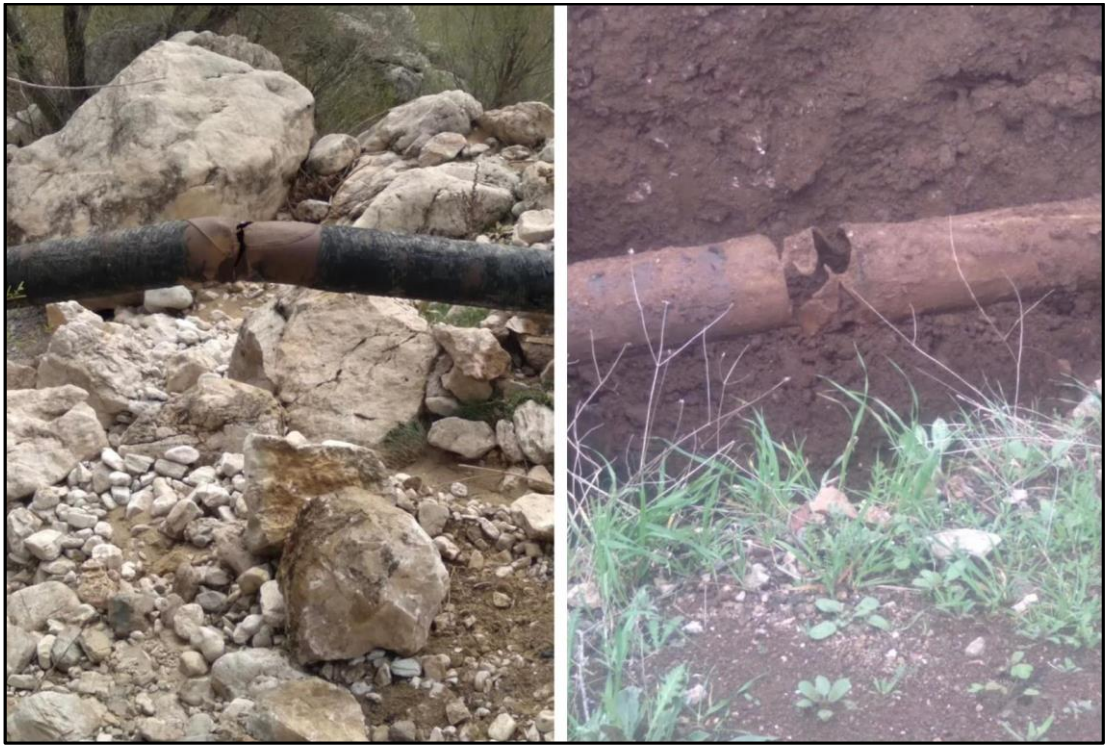
**Figure 6.7:** Damages in steel section of Gürlevik 1 transmission line.

length of 27 km, with the first 15 km constructed of steel. In the steel section extending to the Durukaynak region, a total of 82 damages were recorded. These damages start from the initial kilometers of the line and continue to the end of the 15 km steel segment. The remaining 12 km of the line consists of AC-type pipes, where an uncountable number of damages occurred. Due to the extent of these damages, the ASKİM personnel were insufficient in number to carry out the repairs, necessitating support from other institutions. **Figure 6.7** presents some damage views from different two damage points in 82 damages of steel section of Gürlevik 1 line. The diameter of the damaged pipes is  $\Phi$  300 mm.

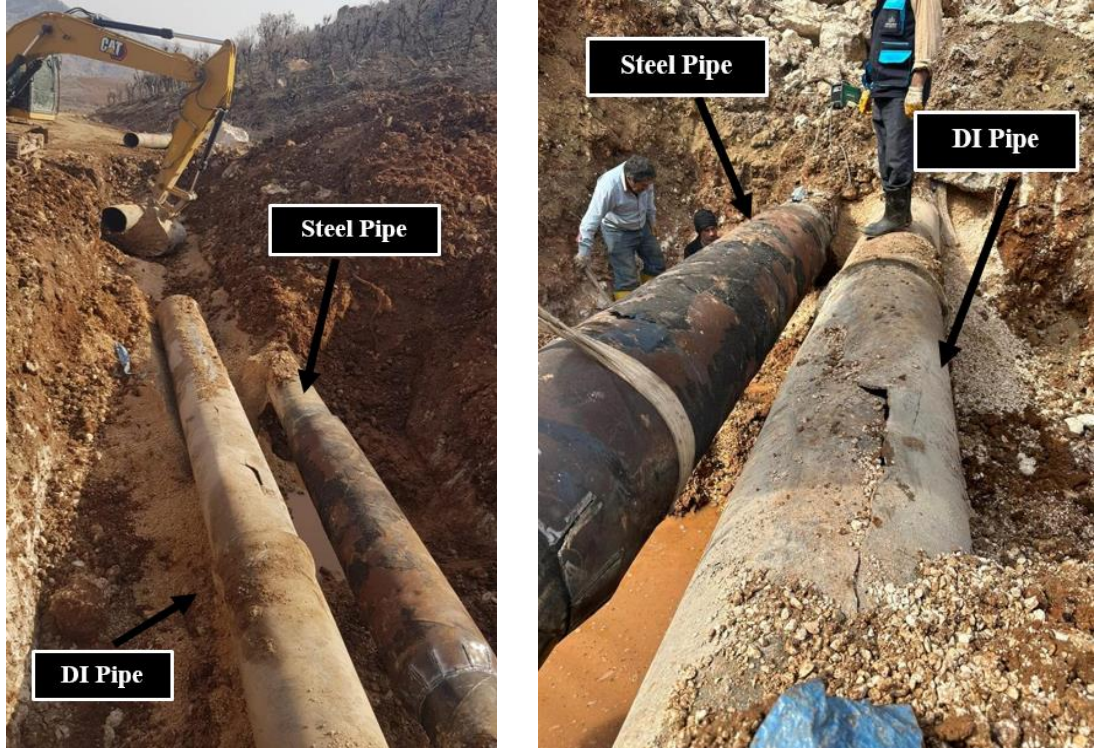
**Figure 6.8:** Damages in Gürlevik DI and 2 transmission lines due to rock falls.

uncovered due to the ongoing construction of the pipeline. The damages occurring in DI pipes, leading to deformation and displacement, are typically observed at the joints under repetitive loading conditions [Liu and Cui, 2025]. However, in this specific case, the body of the exposed DI pipe was damaged by the rock fall. This emphasizes the importance of burying pipelines in areas at risk of landslides to mitigate potential damage.

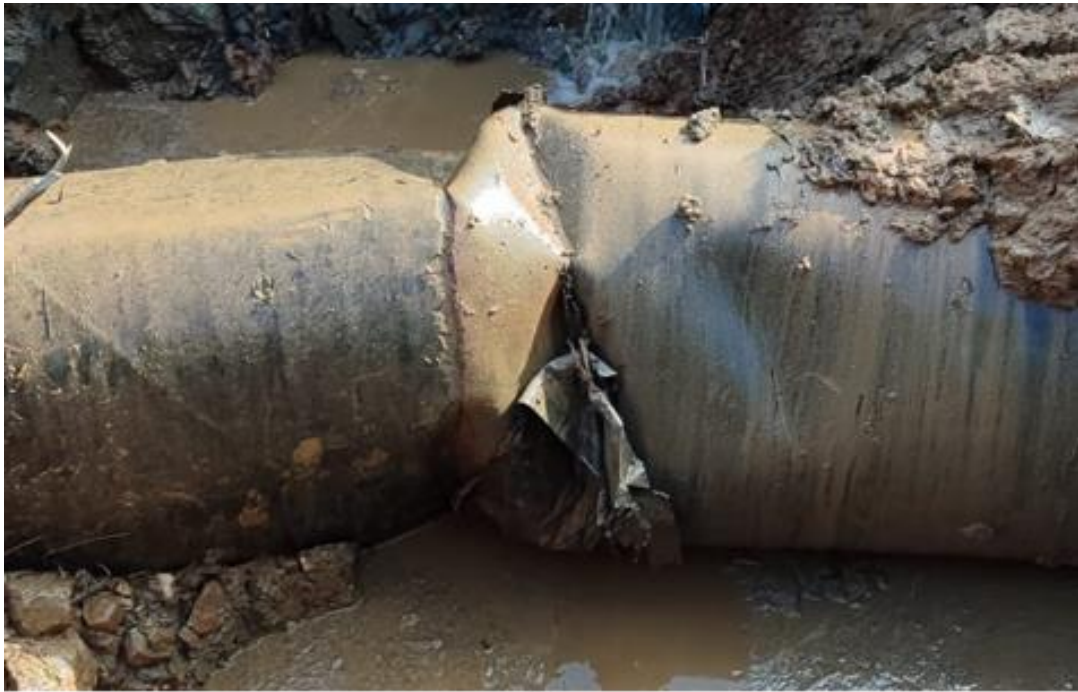
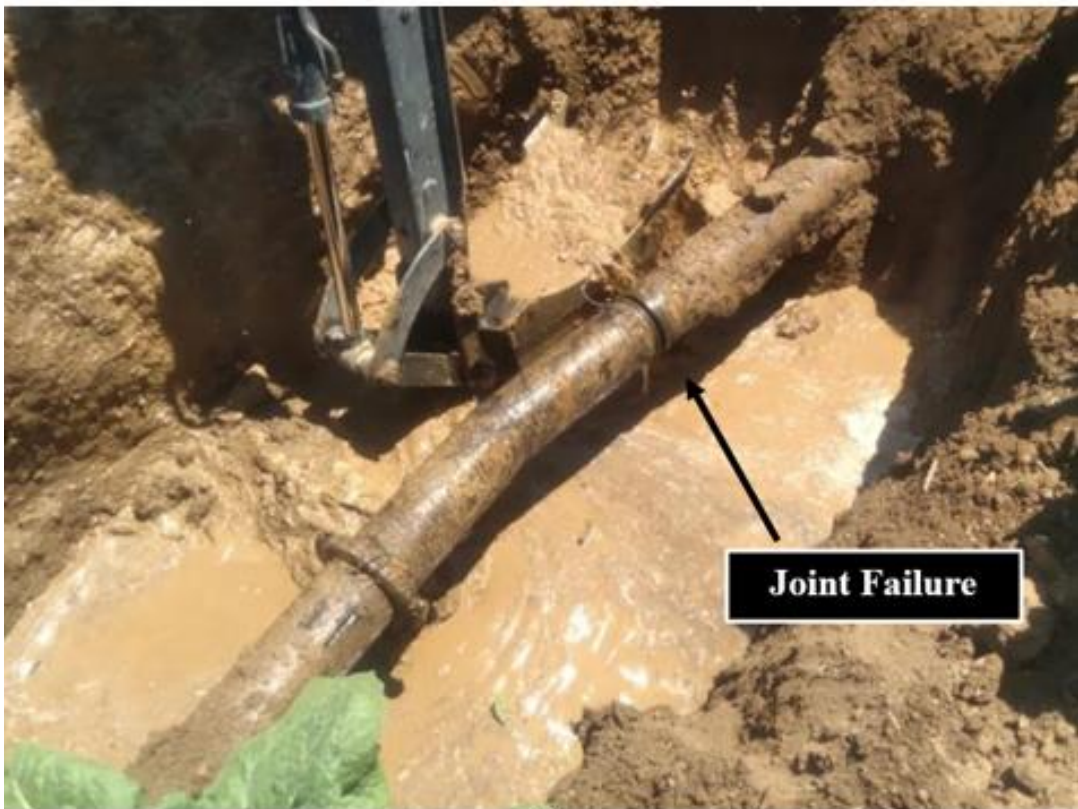
**Figure 6.9:** Different types of damages in Adıyaman: a) Local buckling failure  
b) Joint failure.

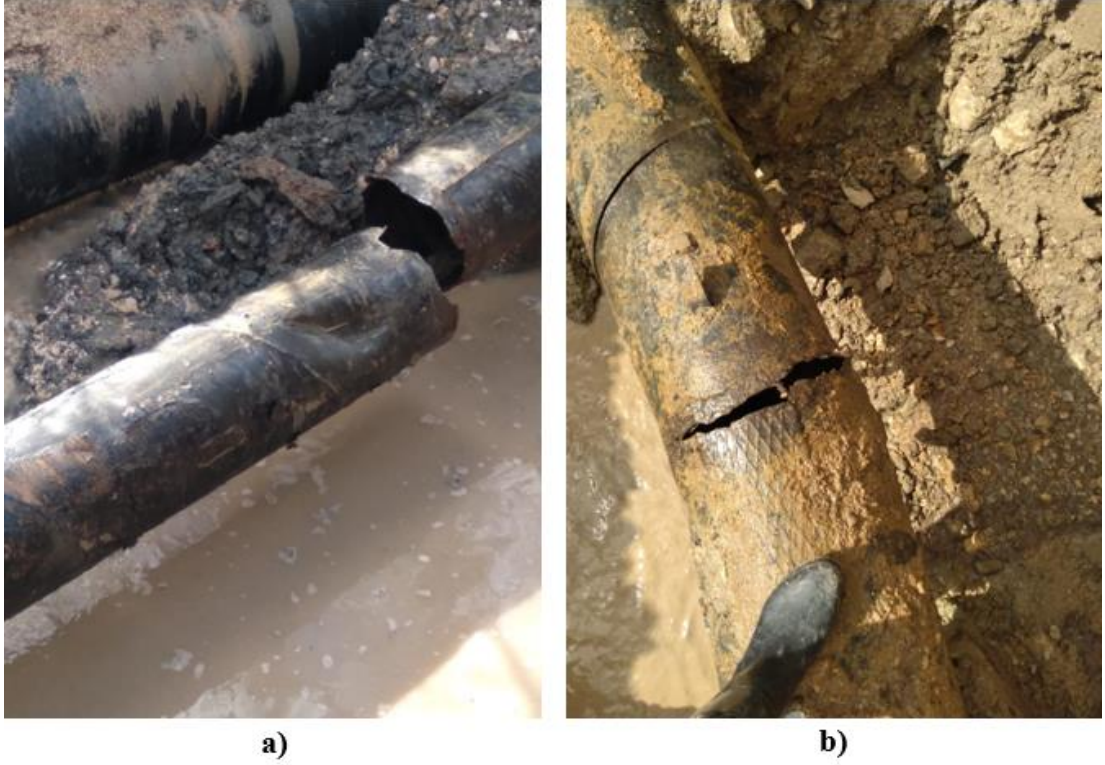
**Figure 6.10:** Different types of damages in Adıyaman: a) Tension failure b) Bending failure.

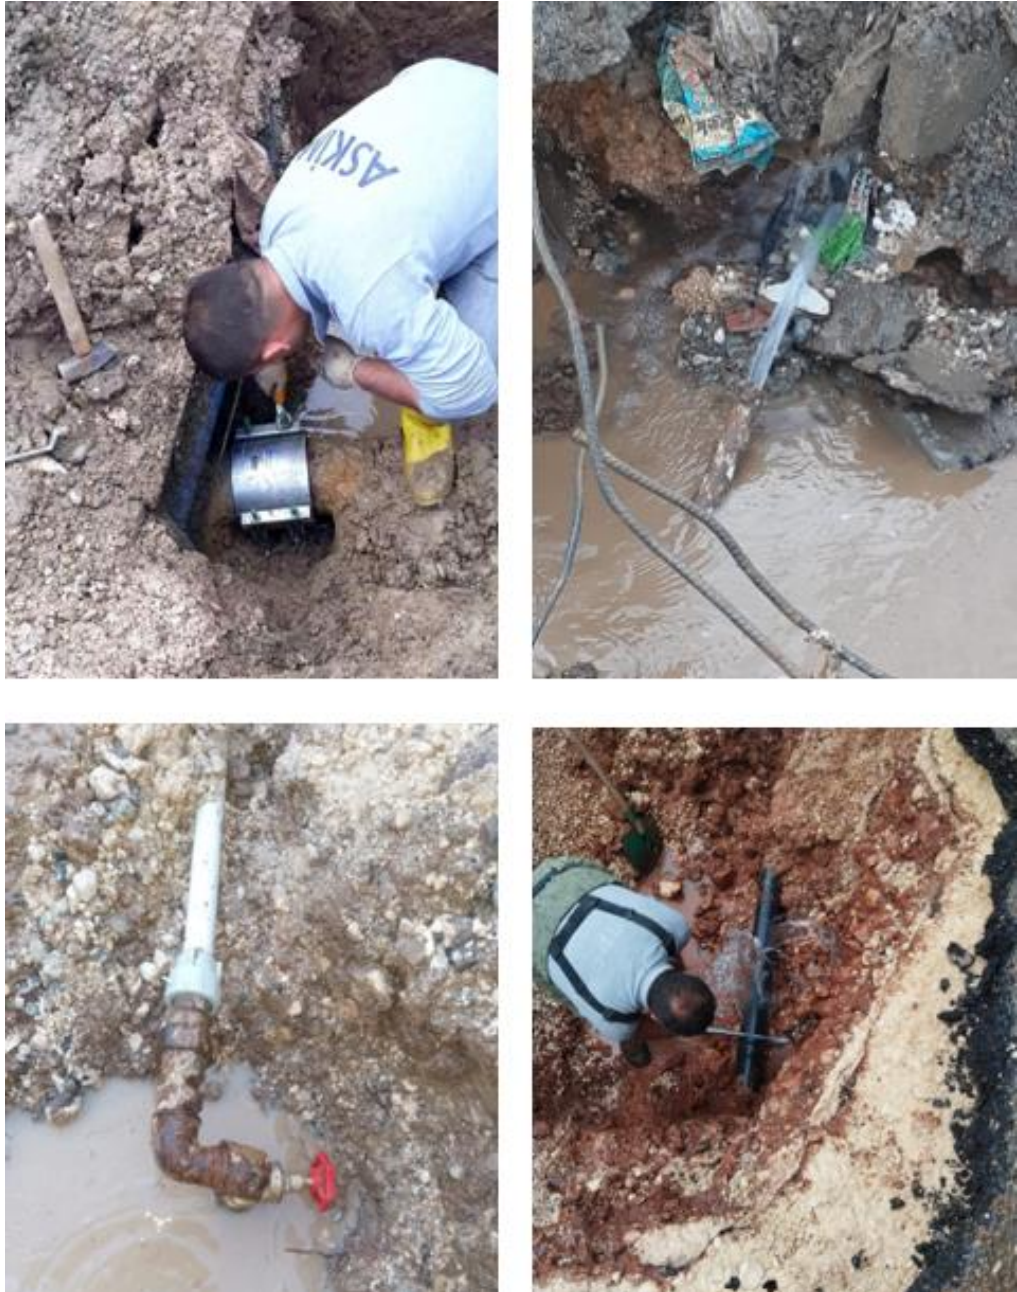
**Figure 6.11:** Some examples from distribution line problems in Adıyaman city center (ASKİM personal communication).

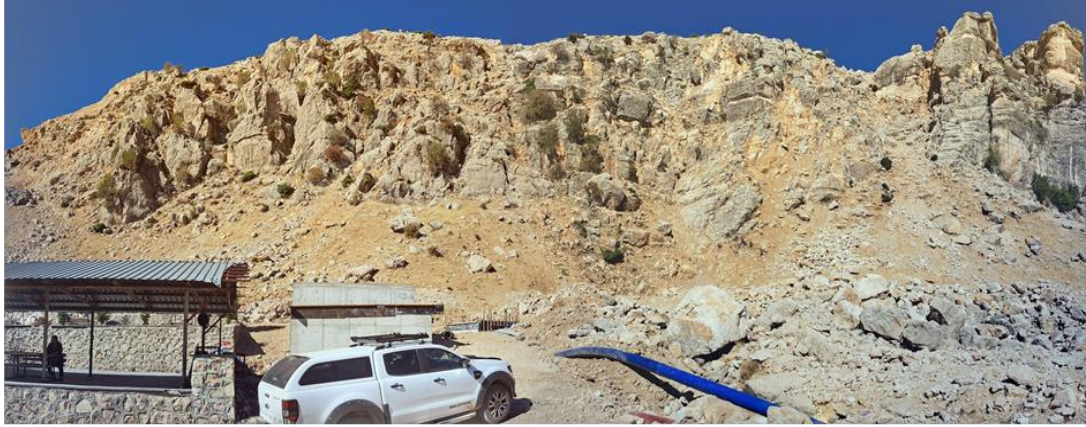
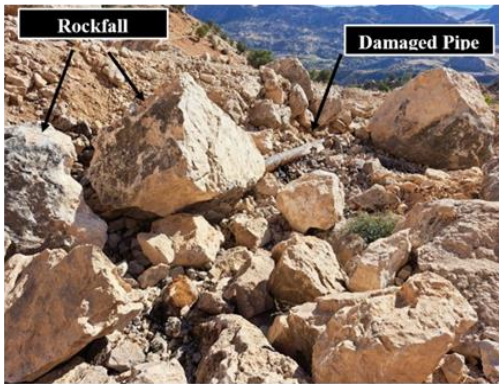
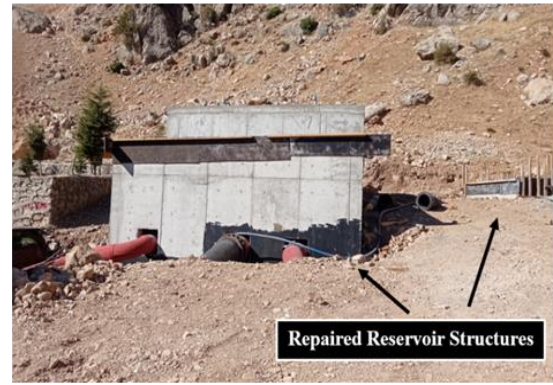
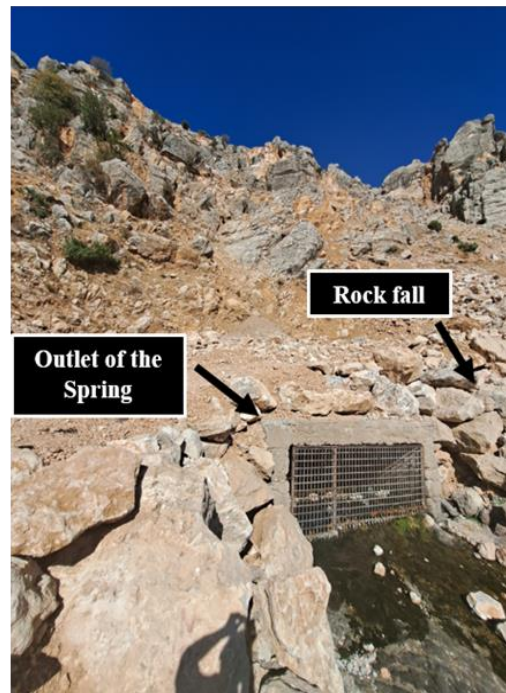
between the source point in question and the nearest fault is approximately 7 kilometers. The water source is located in a steep and rugged terrain, which serves as the primary cause of the earthquake-induced rock falls mentioned. Rock falls triggered by the earthquake caused damage to the reservoir structure, the water outlet of the source, and public facilities located at the spring point of the Gürlevik 2 transmission line. At the Gürlevik spring point, the rock falls included blocks with a maximum size of 2.5 meters, with the majority of rock sizes ranging between 1.5 and 2.5 meters.
