**ASSESSMENT OF DAMAGED WATER SUPPLY NETWORKS**  
**DURING FEBRUARY 6<sup>TH</sup> KAHRAMANMARAŞ EARTHQUAKES:**  
**THE CASE OF ADIYAMAN**

**ADEM EREN ŞENTÜRK**

**A THESIS OF MASTER OF SCIENCE**  
**DEPARTMENT OF CIVIL ENGINEERING**

**JANUARY 2025**

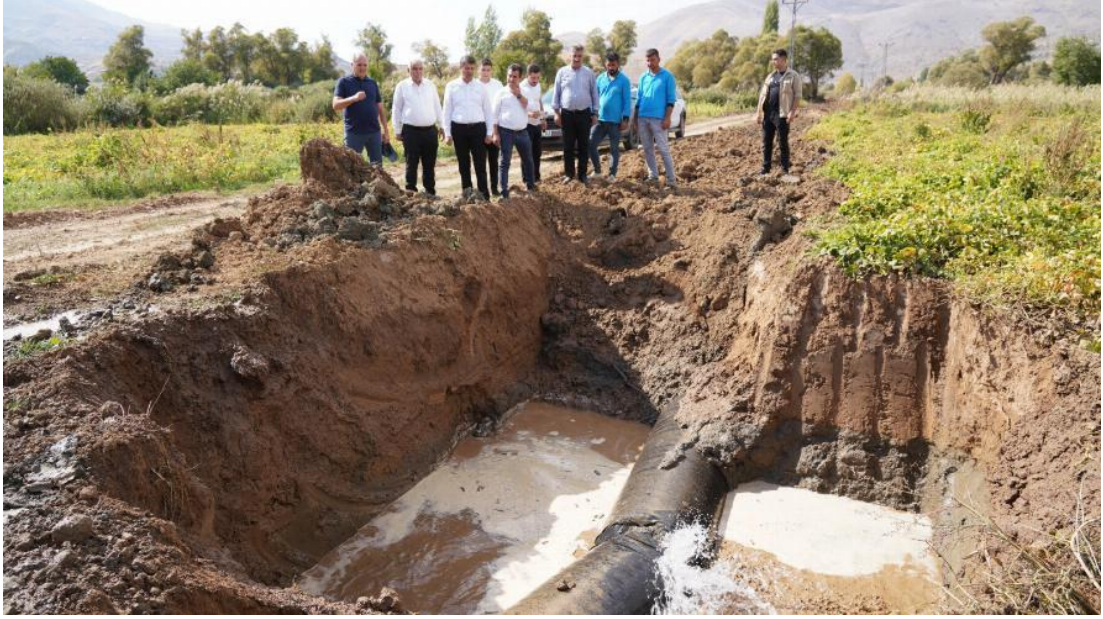
**Figure 6.1:** An example from field studies conducted on the Havşeri transmission line [Adıyaman Municipality, 2024].

A series of significant transmission line failures along the Havşeri pipeline were identified immediately after the earthquake, as the pipeline's flow rate dropped by nearly half. **Figure 6.1** indicates that still water losses caused by damage have occurred at certain points along the transmission line.

The existing pipeline traverses vast plains and intersects with the faulting zone where the Sürgü and Pötürge segments of the East Anatolian Fault Line are located. Therefore, it is estimated that faulting and soil amplifications occurring in the vast plains have played a significant role in the damages observed, particularly along the initial kilometers of the pipeline.

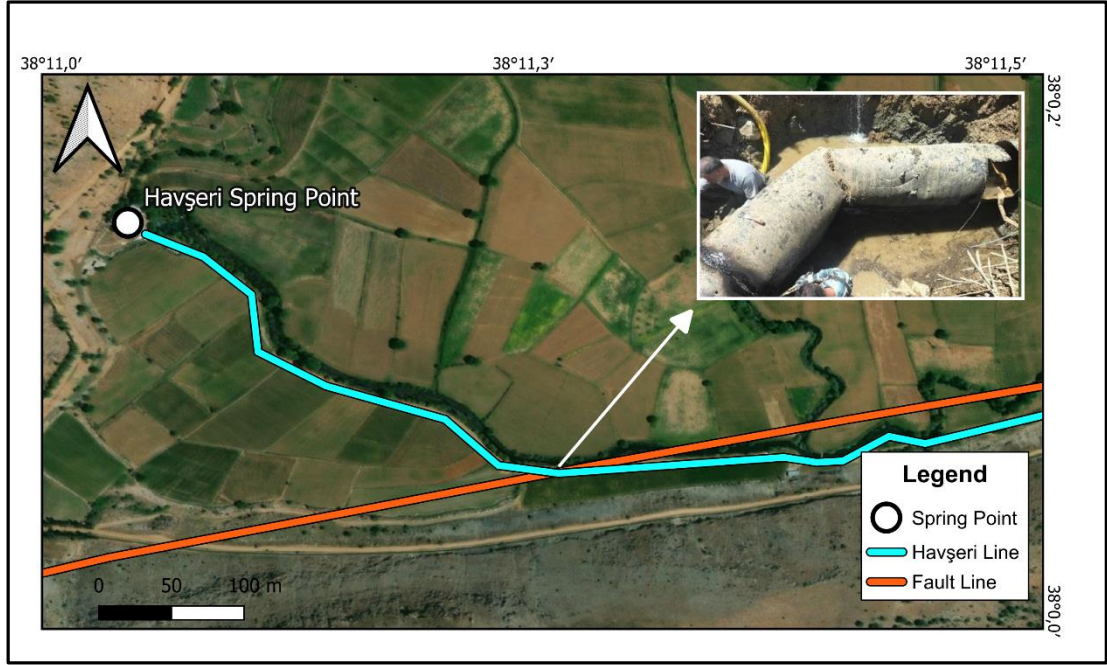
**Figure 6.3** illustrates the anticipated ground movement. Accordingly, the pipeline passes through a wide plain, with a sloped rocky terrain located nearby. Ground movement induced by the left-lateral EAF portion was occurred and resulting in damage to the existing pipeline by bending it at its elbow joint. Further along the same pipeline, at the 2.3-kilometer mark from the source, the pipeline intersects with a surface rupture. The deformation is approximately 2 m at the location of damage point due to fault rupture. It should also be noted that this pipeline, along its 40-km route, traverses steep terrains, areas with slope variations, and regions with high landslide potential, transporting water to the city through topographies ranging from approximately 1300 meters to 720 meters in elevation.

**Figure 6.3:** The crossing of existing fault line with Havşeri transmission line.

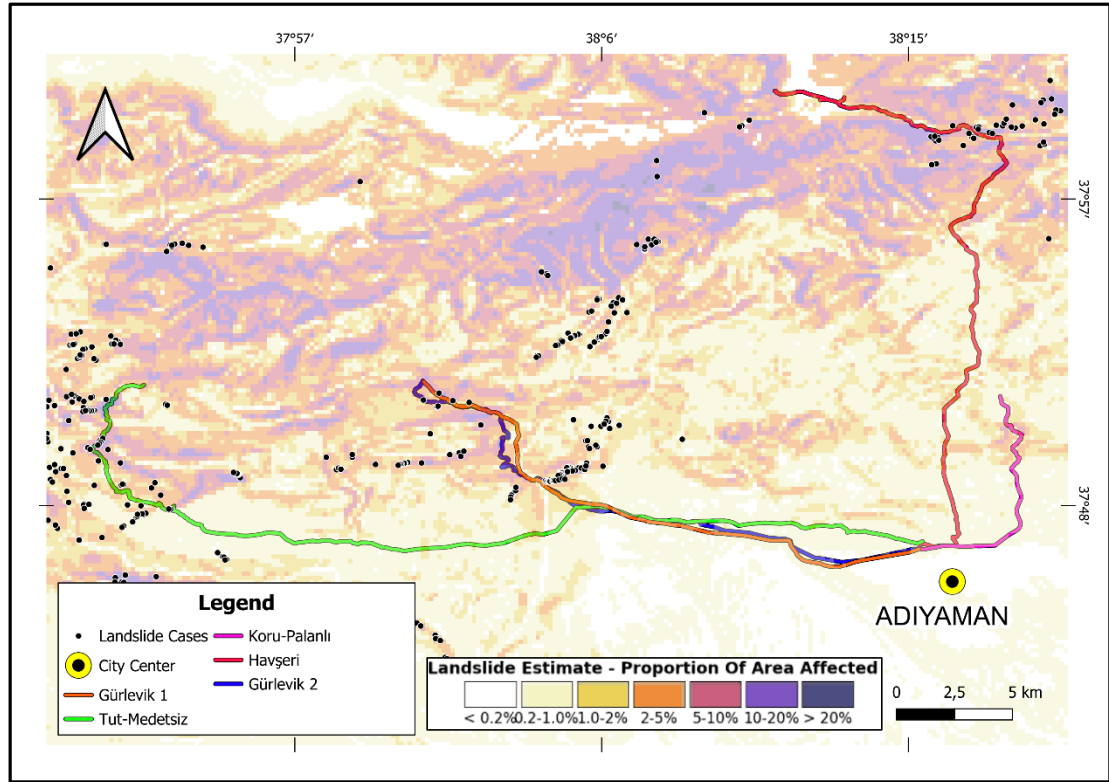
**Figure 6.5** is derived by overlaying the transmission lines supplying water to the Adiyaman city center onto the same map. According to the figure, landslide incidents are observed in certain areas along the Havşeri transmission line, near the source points of the Gürlevik 1 and Gürlevik 2 lines and within the first few kilometers of the Tut-

Medetsiz line. In contrast, no landslide incidents and overlaps with high landslide susceptibility zones are observed along the Kuru-Palanlı transmission line.

**Figure 6.5:** Distribution of landslide cases along with transmission line for Adıyaman city center superimpose with landslide probability model.

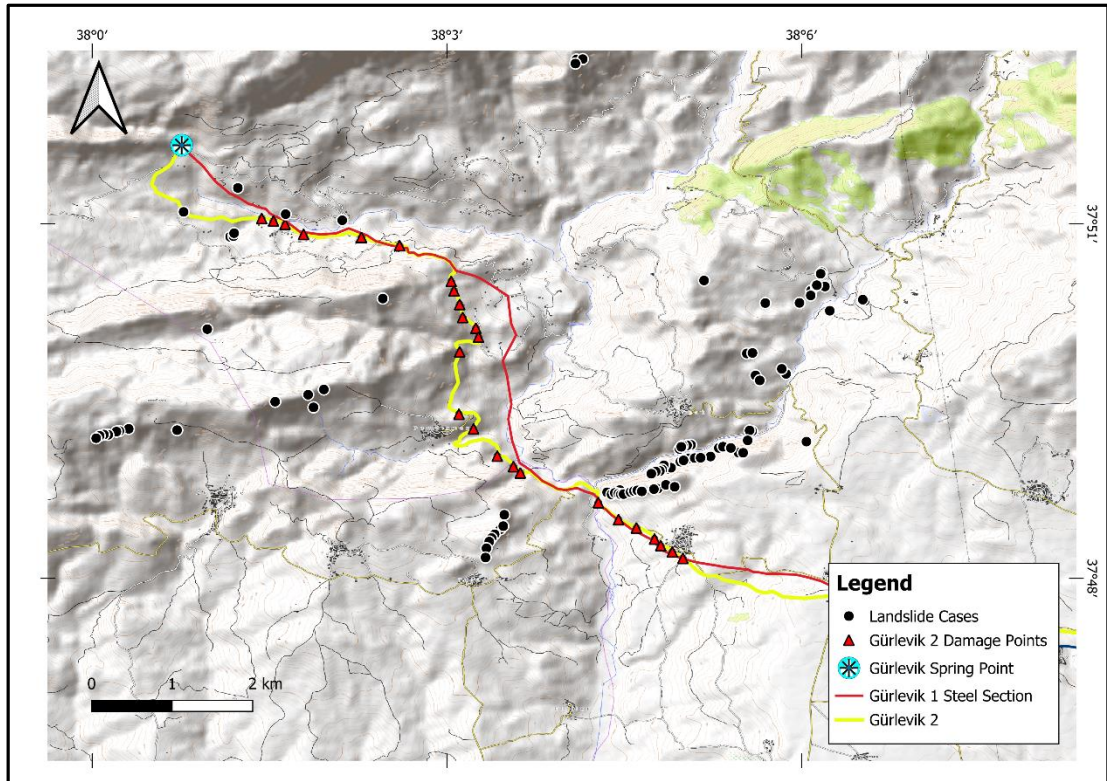
As previously stated, there are 25 identified damages concentrated along approximately 10 km of the 29 km-long Gürlevik 2 pipeline. Similarly, the initial 15 km steel section of the 27 km Gürlevik 1 pipeline contained 82 damages distributed throughout the pipeline. Additionally, several structural facilities were damaged due to rock falls triggered by the earthquake that occurred at the Gürlevik source point. **Figure 6.13** illustrates the earthquake-induced landslides around the Gürlevik source area following the Kahramanmaraş earthquakes and depicts the relative positions of these landslide locations based on the study conducted by **Görüm et al. [2023]** in relation to the Gürlevik 1 and Gürlevik 2 pipelines. The figure reveals some intersections between actual landslide incidents and the pipeline routes. Additionally, it is anticipated that, in addition to the landslides shown in the figure, other unreported landslides may have also occurred along the Gürlevik 1 and Gürlevik 2 pipelines.

**Figure 6.13:** The spatial distributions of landslides, Gürlevik water supply networks relevant damages.

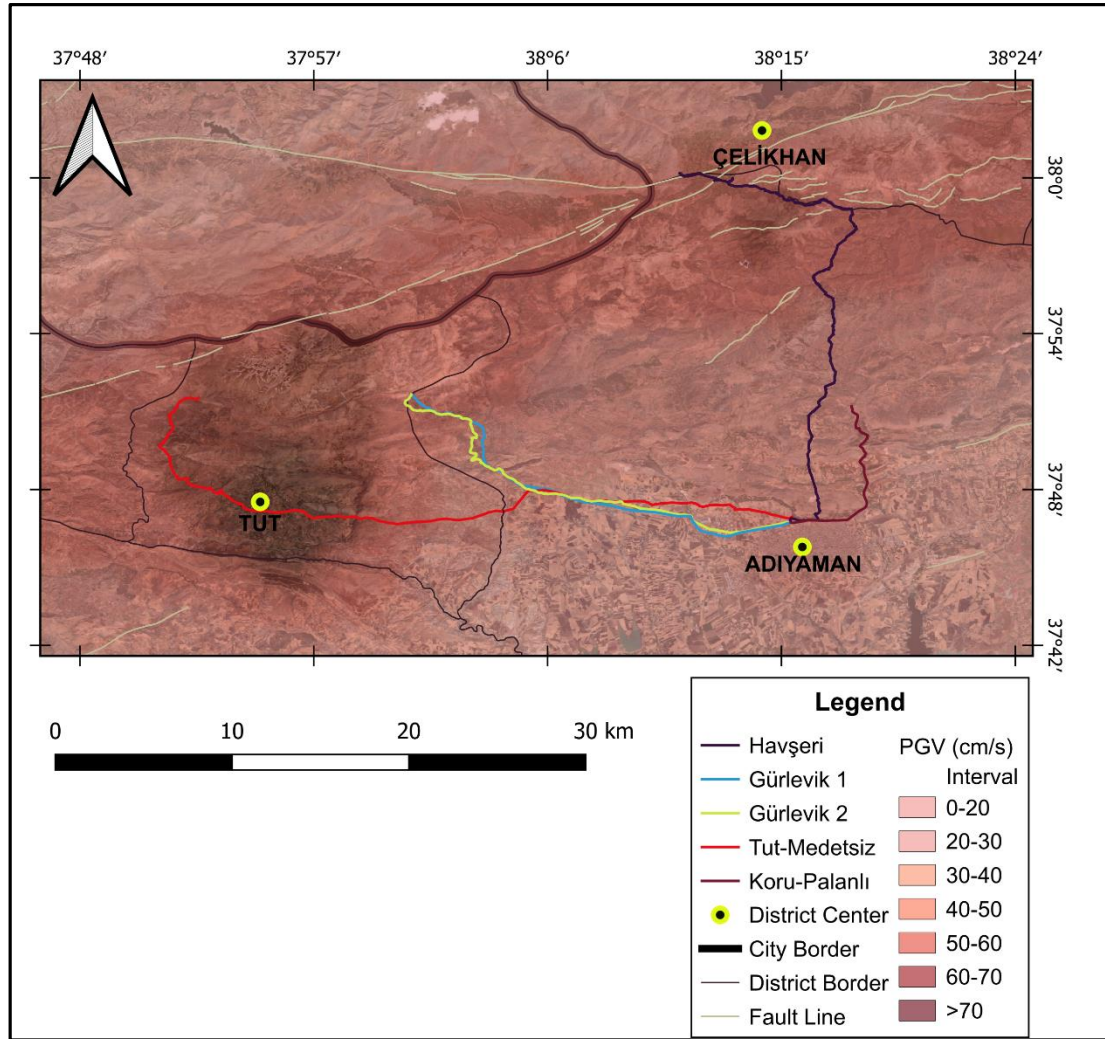
As a result of the analyses, PGV distribution map is presented in **Figure 7.1**. The PGV range for the Gürlevik 2 pipeline was determined to be 27-50 cm/s, with the damaged region falling within the range of 31-46 cm/s. The PGV range for the Gürlevik 1 transmission pipeline was found to be 28-48 cm/s, while the PGV range for the Koru-Palanlı transmission pipeline was determined to be 30-32 cm/s. For the Havşeri transmission pipeline, the PGV range was calculated as 32-54 cm/s, with the PGV value at the damage point coinciding with the fault measured as 43 cm/s. In the Tut-Medetsiz transmission pipeline, the PGV range was obtained as 27-86 cm/s. In the city center of Adıyaman, the PGV range was determined to be 30-35 cm/s, with the

maximum value recorded in the Alitaşı neighborhood, where the highest number of network damages occurred. Results are presented in **Table 7.1**. Besides, PGV distribution along the length of the lines are given in **Table 7.2**.

**Figure 7.1:** PGV distribution map of Adıyaman city center and nearby districts.

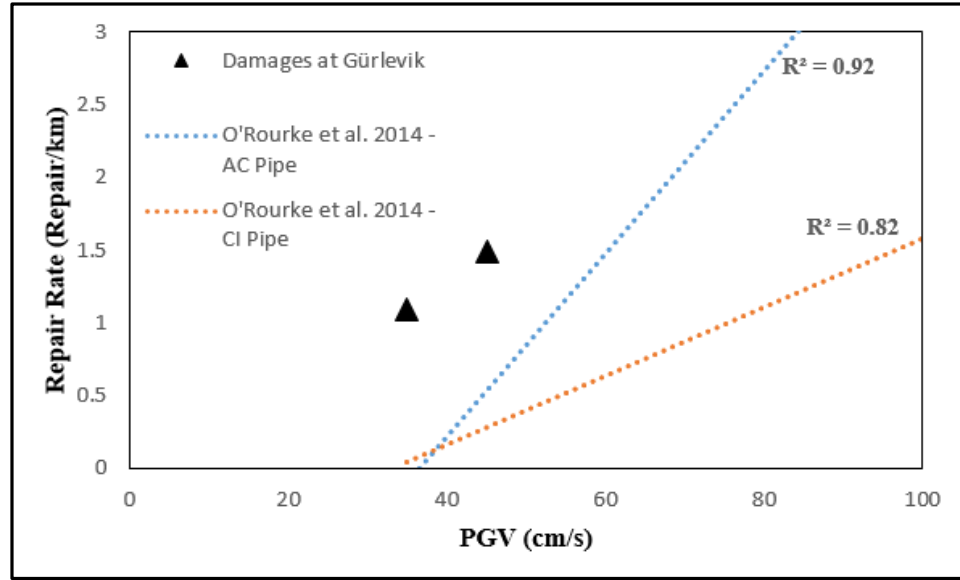
Additionally, the RR data obtained from the Gürlevik 2 pipeline are presented in **Figure 7.2** alongside the corresponding PGV values. In the figure, the correlations provided by **O'Rourke et al. [2014]** for AC and CI pipe types are compared with the data specific to Gürlevik 2 in a comparative manner.

**Figure 7.2:** Comparison of damage data from Gürlevik 2 with the literature.

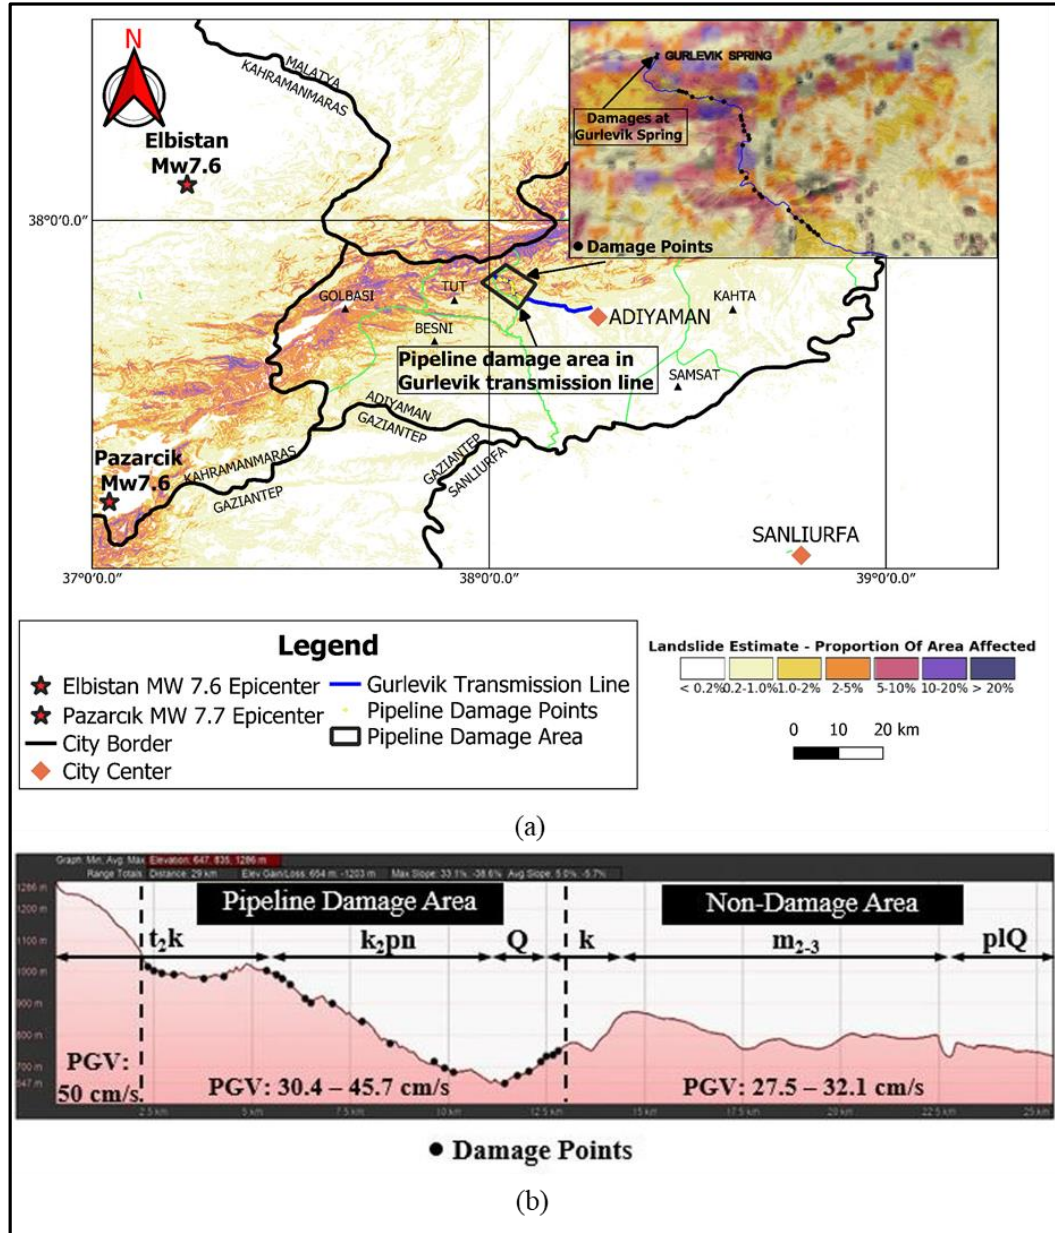
**Figure 7.3a** introduces the USGS landslide hazard prediction map which has been superimposed on the Gürlevik 2 steel pipeline route. The model has been developed using an empirical model by **Nowicki Jessee et al. [2018]** as mentioned before.

**Figure 7.3b** illustrates the elevation profile of the Gürlevik 2 pipeline, highlighting 25 damage points along its route and their respective distances. It also incorporates the lithological structures traversed by the pipeline as previously detailed in **Table 6.1**. The figure is generated using Google Earth™ and displays the elevation profile along the pipeline route with parallel to the pipeline. The x-axis denotes the actual ground distance and the y-axis represents the elevation above sea level. It is worth noting that the elevation data obtained from Google Earth may pose certain limitations.

**Figure 7.3:** Details of the terrain where Gürlevik 2 transmission line passes.

The precision of this data may fluctuate, with typical errors ranging between 10 to 30 m, depending on factors like data resolution and its sources, such as the Shuttle Radar Topography Mission (SRTM) [Toprak et al., 2024a]. The figure also illustrates the variation in peak ground velocity (PGV) values along the pipeline route. In the heavily damaged sections of the pipeline, PGV values range from 30.4 to 45.7 cm/s, whereas in undamaged sections, the values are between 27.5 and 32.1 cm/s. Additionally, at the source point of the pipeline, the PGV value is approximately 50 cm/s. These PGV values were derived from the study by Toprak et al. [2024d].

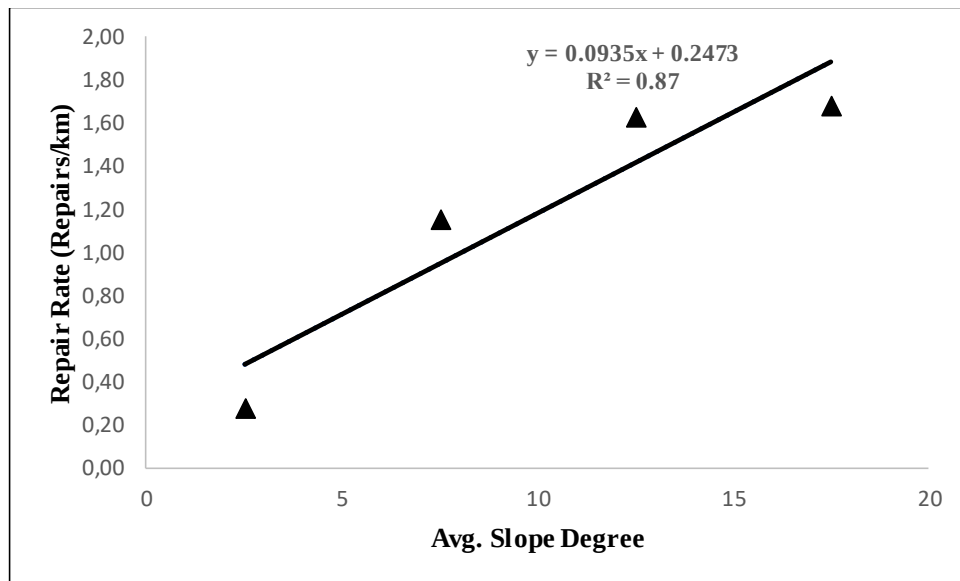
In **Figure 7.4**, the distribution of RR data along the Gürlevik 2 pipeline is presented based on slope degree intervals. In the figure, slope intervals are divided into 5-degree increments within the range of 0 to 20 degrees.

**Figure 7.4:** The correlation of RR and slope degree for Gürlevik 2 line.
